**NIST NCSTAR 1-5A** Federal Building and Fire Safety Investigation of the World Trade Center Disaster

## Visual Evidence, Damage Estimates, **And Timeline Analysis**

(Appendices D-G)

## Appendix D WTC 1 EAST FACE COMBINED FIRE AND WINDOW CONDITION AND WINDOW SMOKE CONDITION

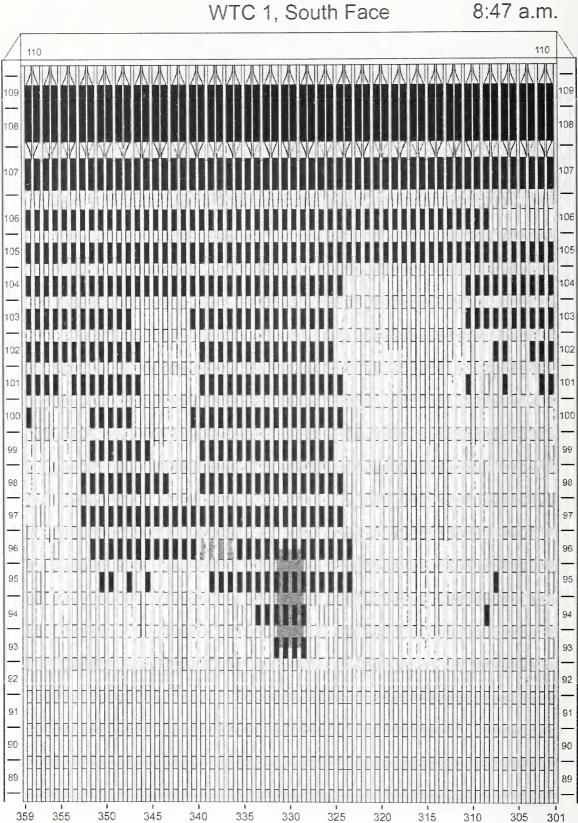
Figure E-1. Diagram of the south face of WTC 1 for floors 89 to 110 at 8:47 a.m. showing the condition of windows and locations of fires.

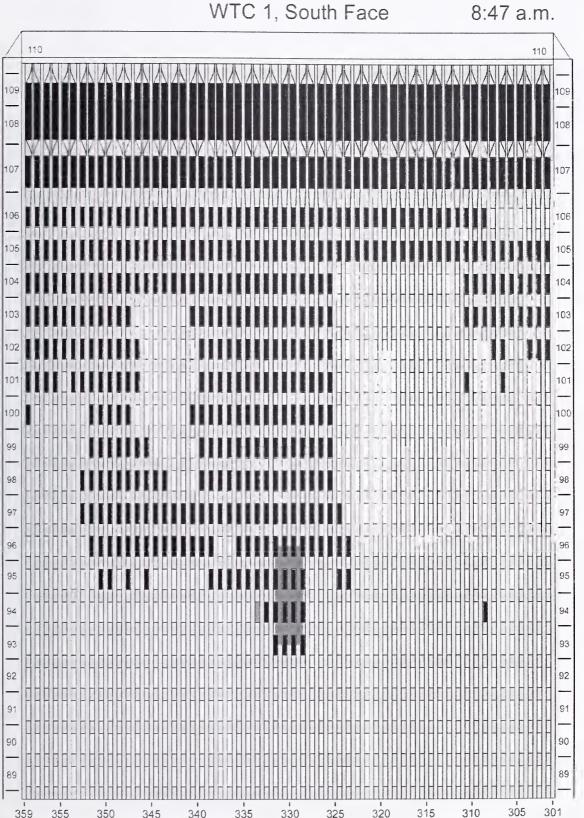
Figure E-2. Diagram of the south face of WTC 1 for floors 89 to 110 at 8:47 a.m. showing windows where smoke was observed and those that were hidden from view.

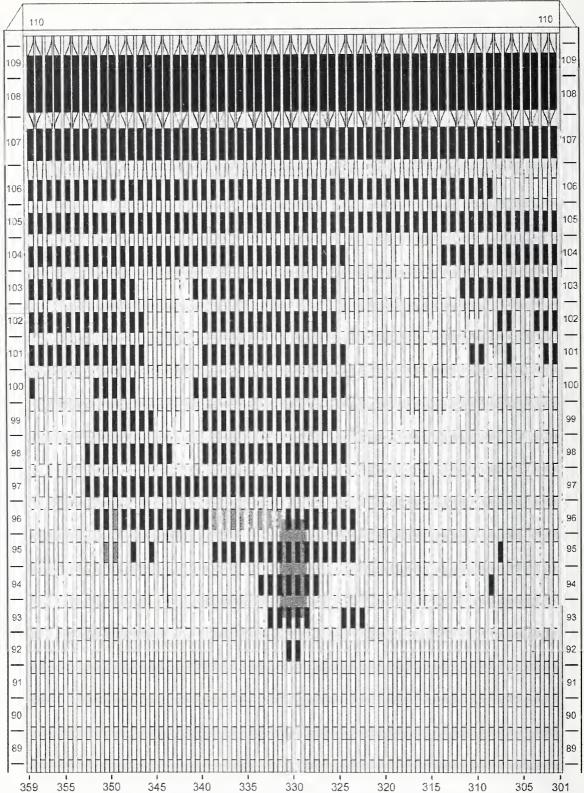
Figure E-3. Diagram of the south face of WTC 1 for floors 89 to 110 at 8:52 a.m. showing the condition of windows and locations of fires.

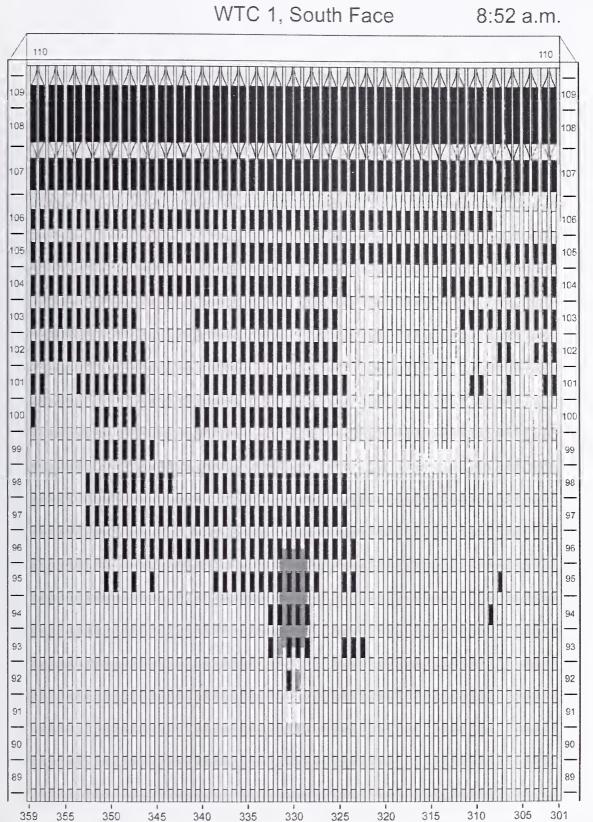
Figure E-4. Diagram of the south face of WTC 1 for floors 89 to 110 at 8:52 a.m. showing windows where smoke was observed and those that were hidden from view.

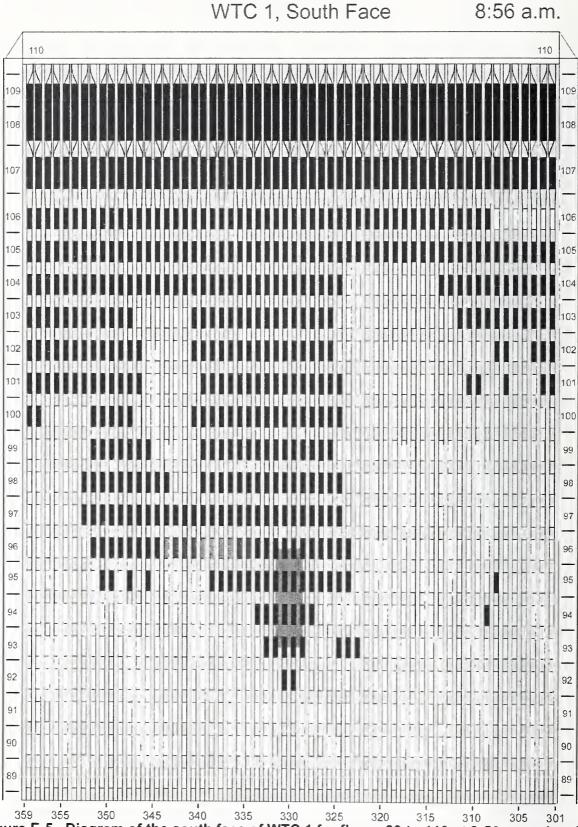
Figure E-5. Diagram of the south face of WTC 1 for floors 89 to 110 at 8:56 a.m. showing the condition of windows and locations of fires.

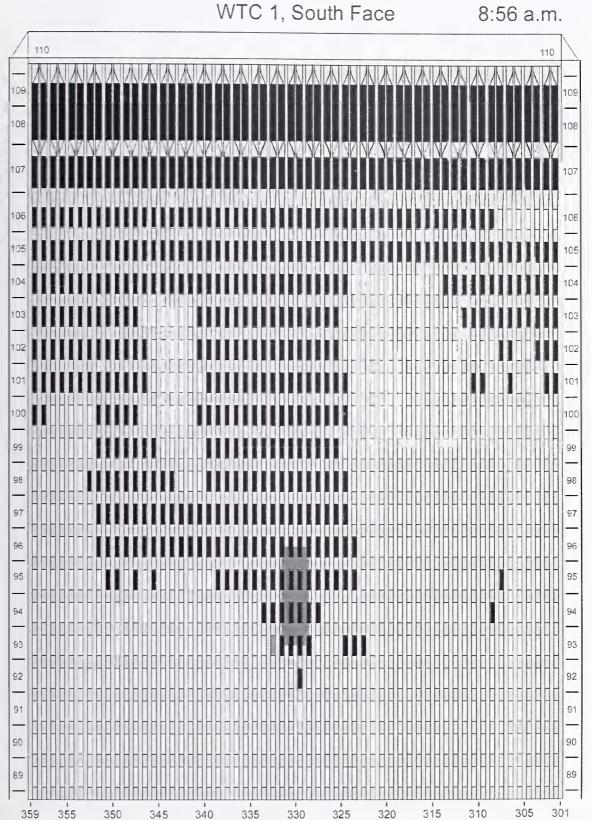
Figure E-6. Diagram of the south face of WTC 1 for floors 89 to 110 at 8:56 a.m. showing windows where smoke was observed and those that were hidden from view.

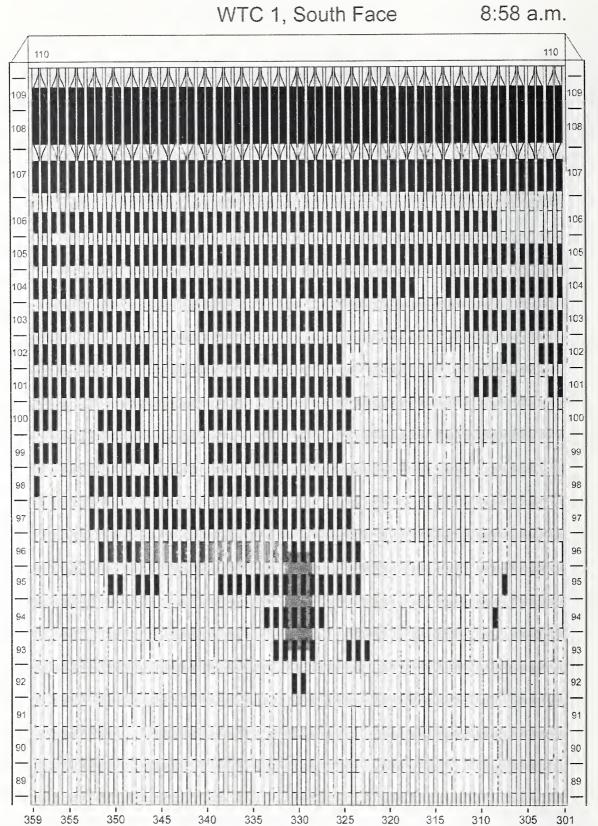
Figure E-7. Diagram of the south face of WTC 1 for floors 89 to 110 at 8:58 a.m. showing the condition of windows and locations of fires.

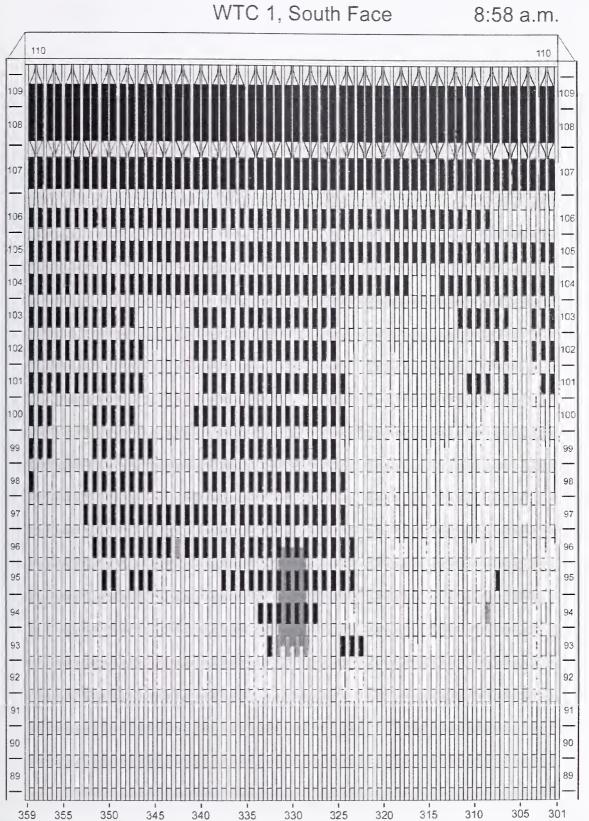
Figure E-8. Diagram of the south face of WTC 1 for floors 89 to 110 at 8:58 a.m. showing windows where smoke was observed and those that were hidden from view.

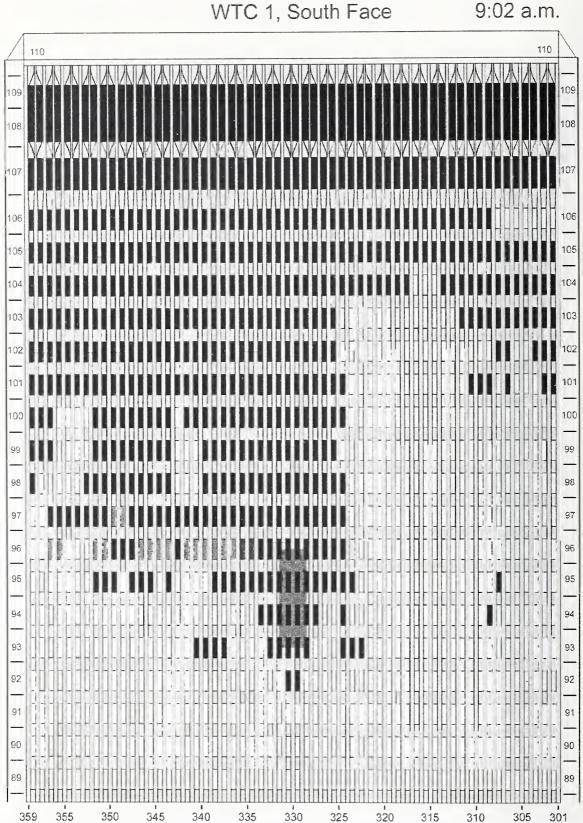
Figure E-9. Diagram of the south face of WTC 1 for floors 89 to 110 at 9:02 a.m. showing the condition of windows and locations of fires.

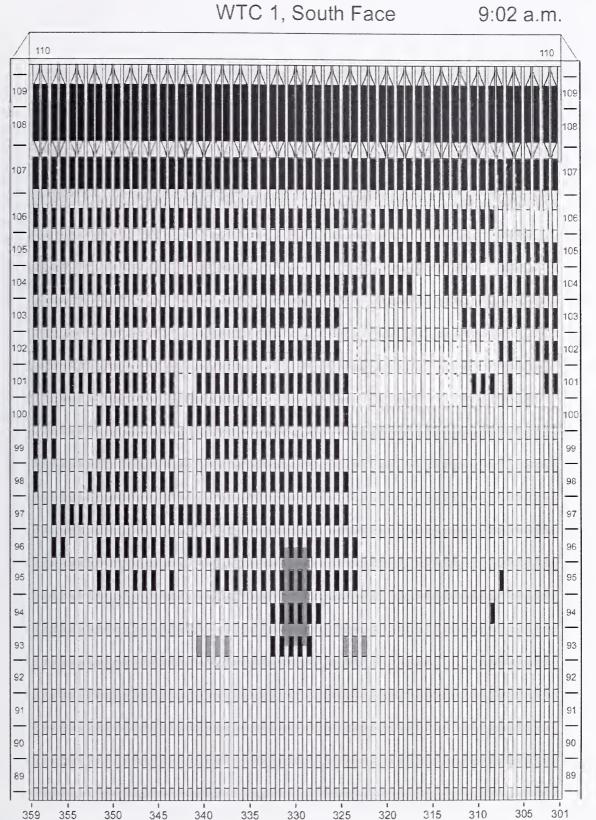
Figure E-10. Diagram of the south face of WTC 1 for floors 89 to 110 at 9:02 a.m. showing windows where smoke was observed and those that were hidden from view.

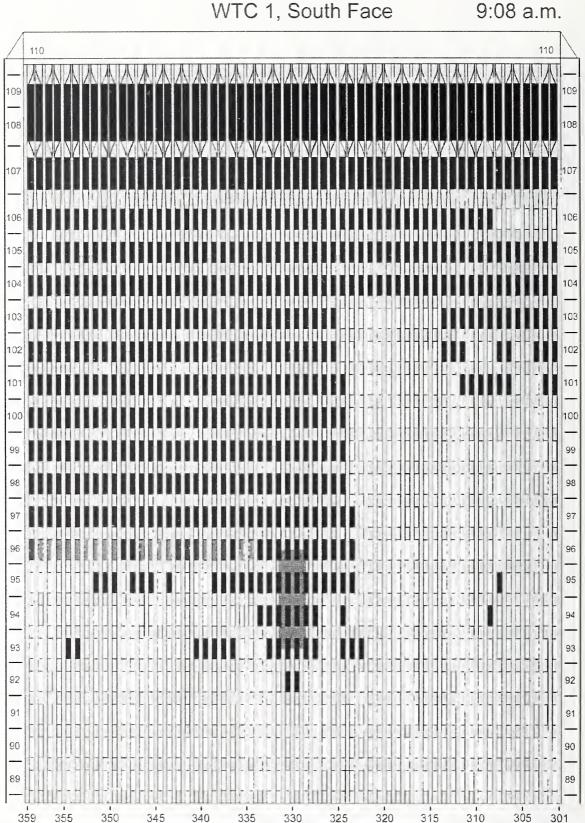
Figure E-11. Diagram of the south face of WTC 1 for floors 89 to 110 at 9:08 a.m. showing the condition of windows and locations of fires.

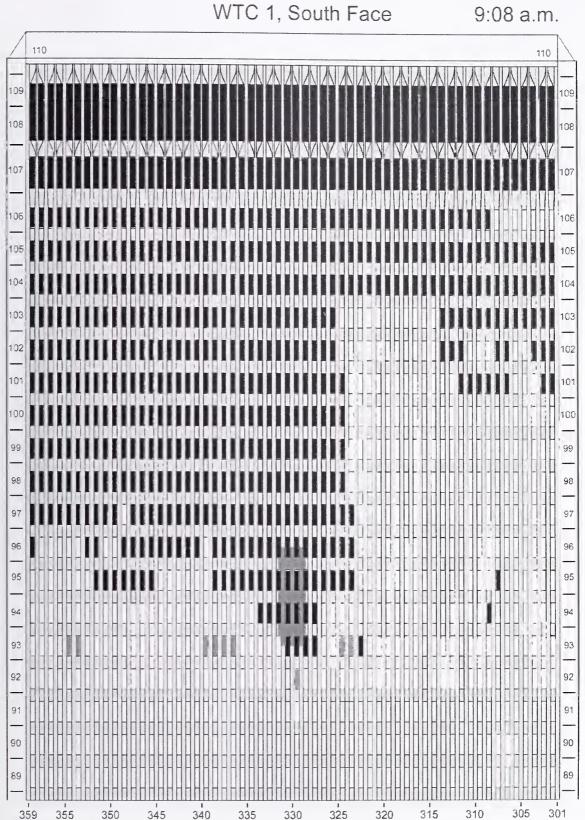
Figure E-12. Diagram of the south face of WTC 1 for floors 89 to 110 at 9:08 a.m. showing windows where smoke was observed and those that were hidden from view.

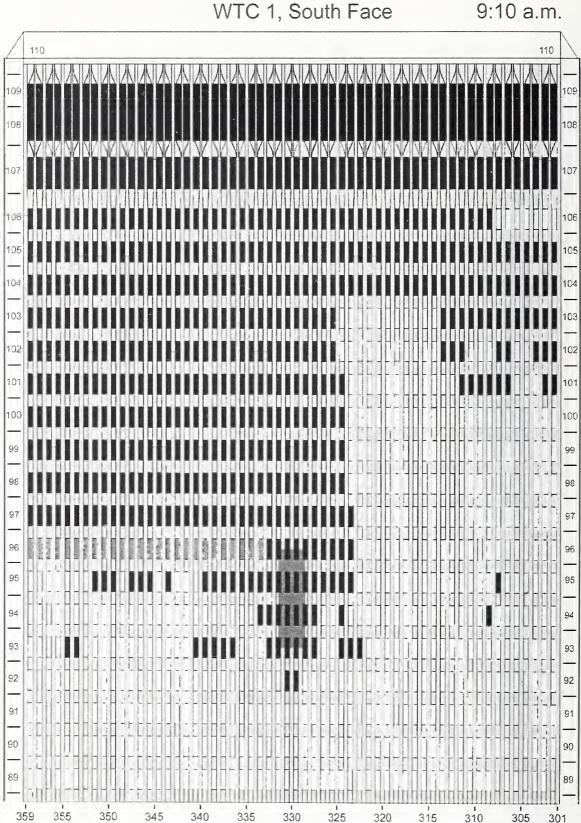
Figure E-13. Diagram of the south face of WTC 1 for floors 89 to 110 at 9:10 a.m. showing the condition of windows and locations of fires.

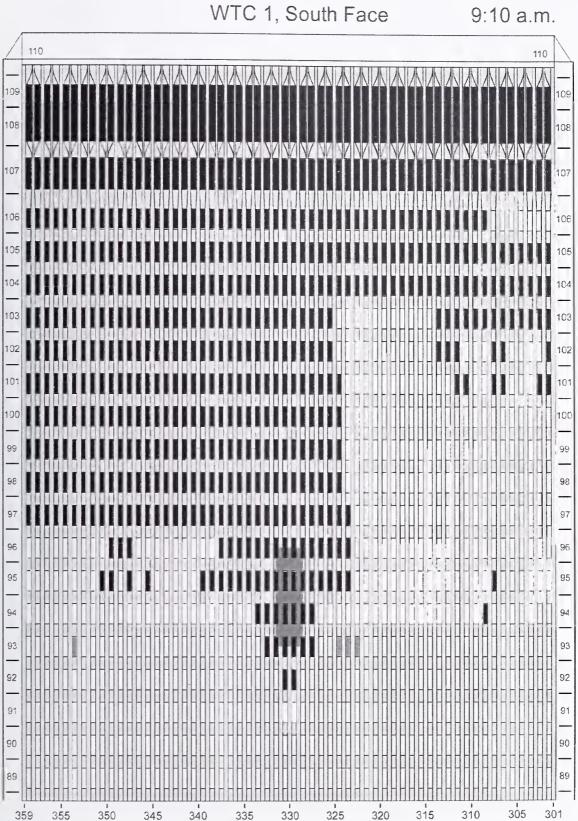
Figure E-14. Diagram of the south face of WTC 1 for floors 89 to 110 at 9:10 a.m. showing windows where smoke was observed and those that were hidden from view.

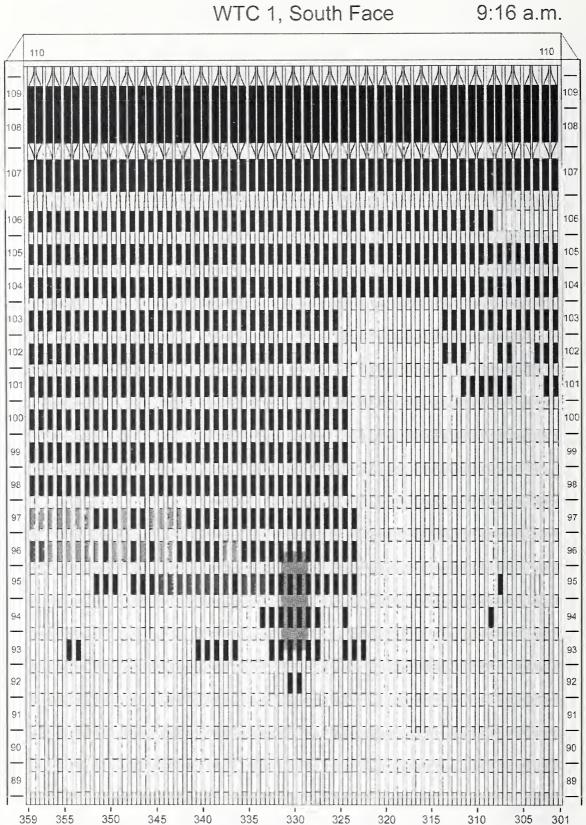
Figure E-15. Diagram of the south face of WTC 1 for floors 89 to 110 at 9:16 a.m. showing the condition of windows and locations of fires.

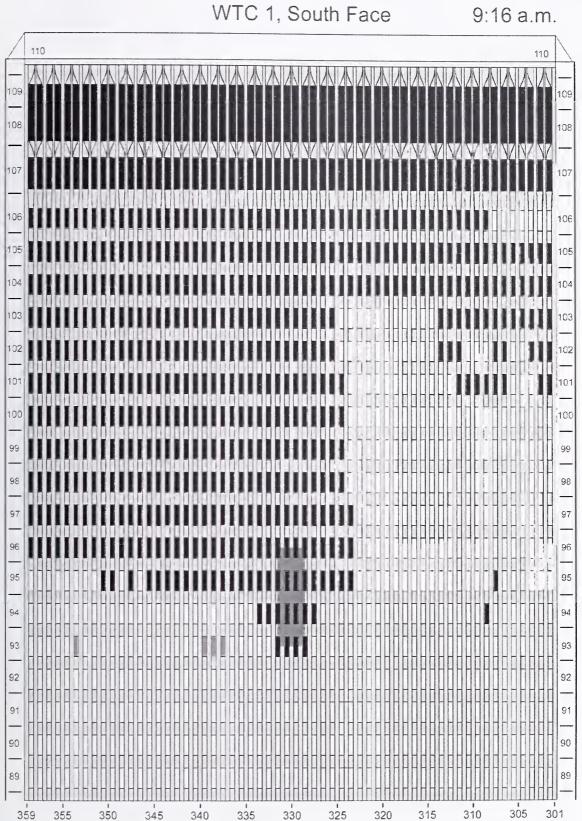
Figure E-16. Diagram of the south face of WTC 1 for floors 89 to 110 at 9:16 a.m. showing windows where smoke was observed and those that were hidden from view.

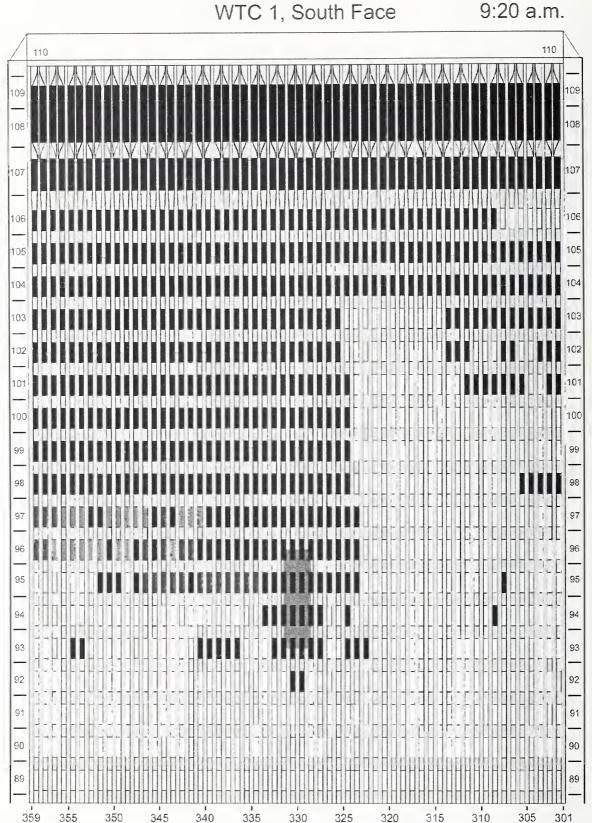
Figure E-17. Diagram of the south face of WTC 1 for floors 89 to 110 at 9:20 a.m. showing the condition of windows and locations of fires.

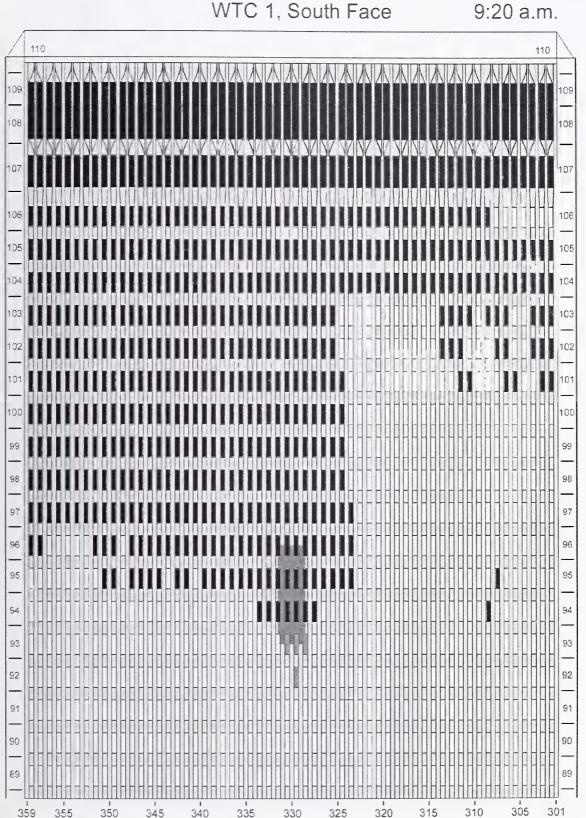
Figure E-18. Diagram of the south face of WTC 1 for floors 89 to 110 at 9:20 a.m. showing windows where smoke was observed and those that were hidden from view.

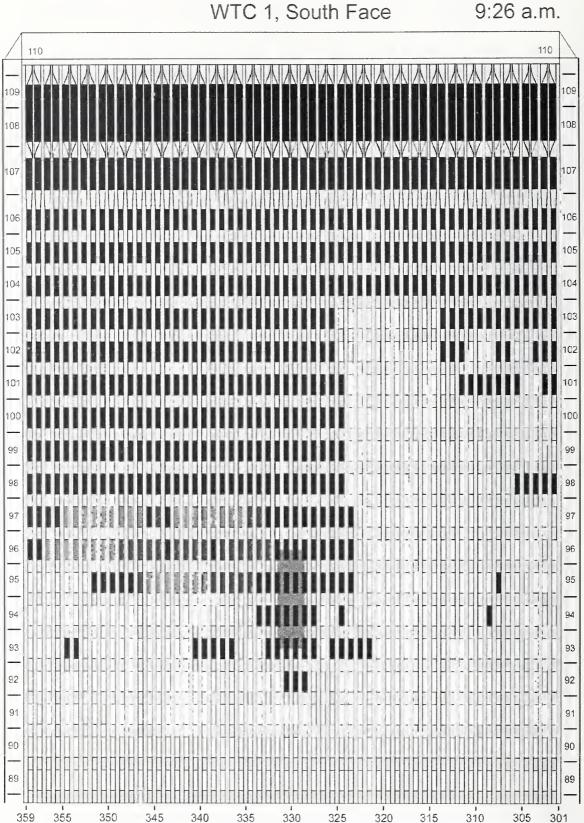
Figure E-19. Diagram of the south face of WTC 1 for floors 89 to 110 at 9:26 a.m. showing the condition of windows and locations of fires.

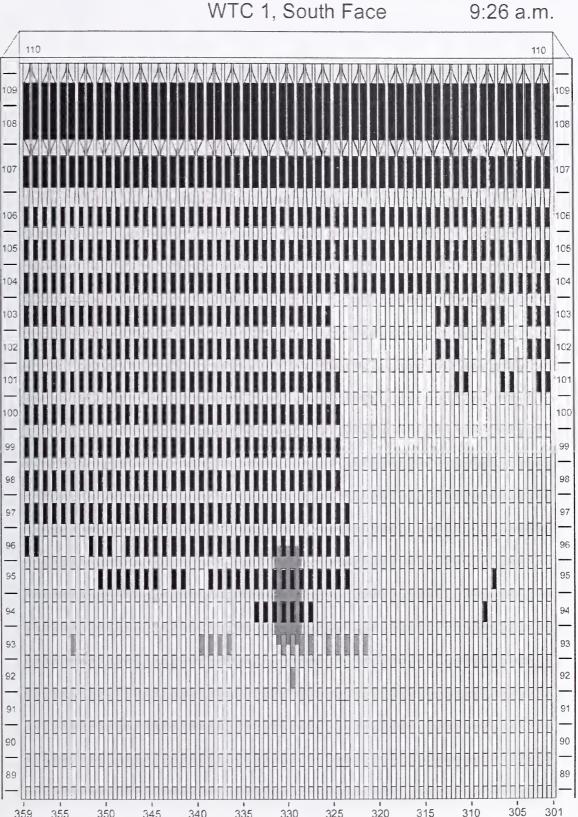
Figure E-20. Diagram of the south face of WTC 1 for floors 89 to 110 at 9:26 a.m. showing windows where smoke was observed and those that were hidden from view.

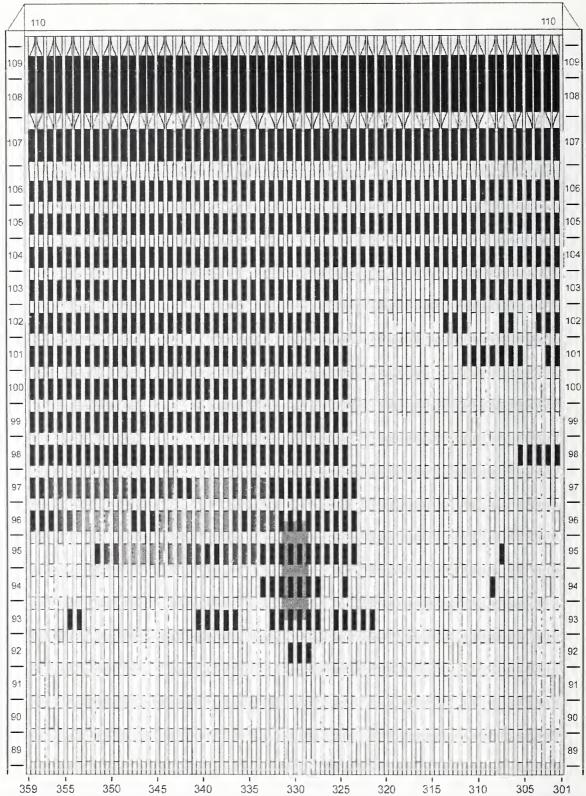
Figure E-21. Diagram of the south face of WTC 1 for floors 89 to 110 at 9:32 a.m. showing the condition of windows and locations of fires.

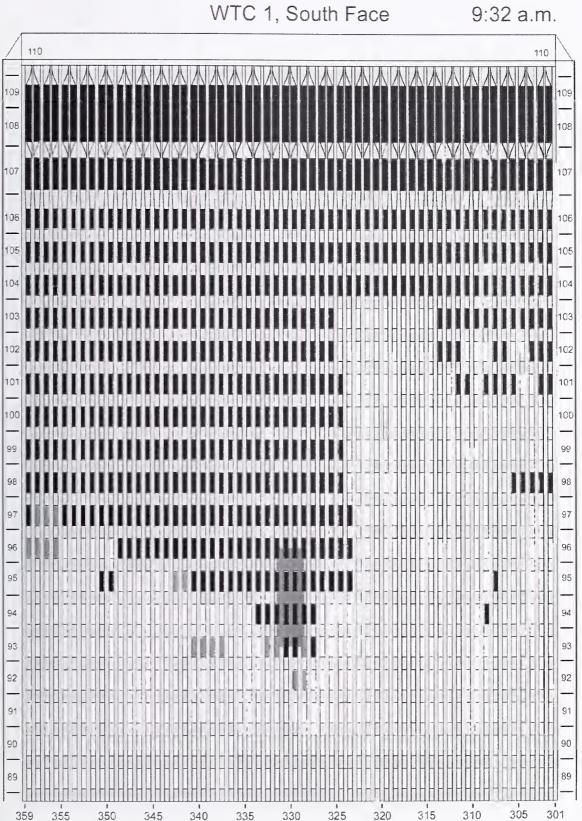
Figure E-22. Diagram of the south face of WTC 1 for floors 89 to 110 at 9:32 a.m. showing windows where smoke was observed and those that were hidden from view.

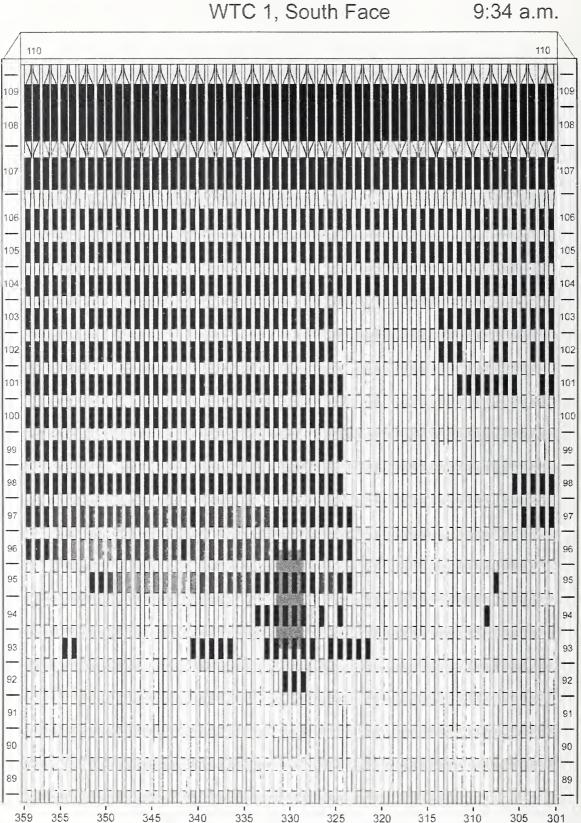
Figure E-23. Diagram of the south face of WTC 1 for floors 89 to 110 at 9:34 a.m. showing the condition of windows and locations of fires.

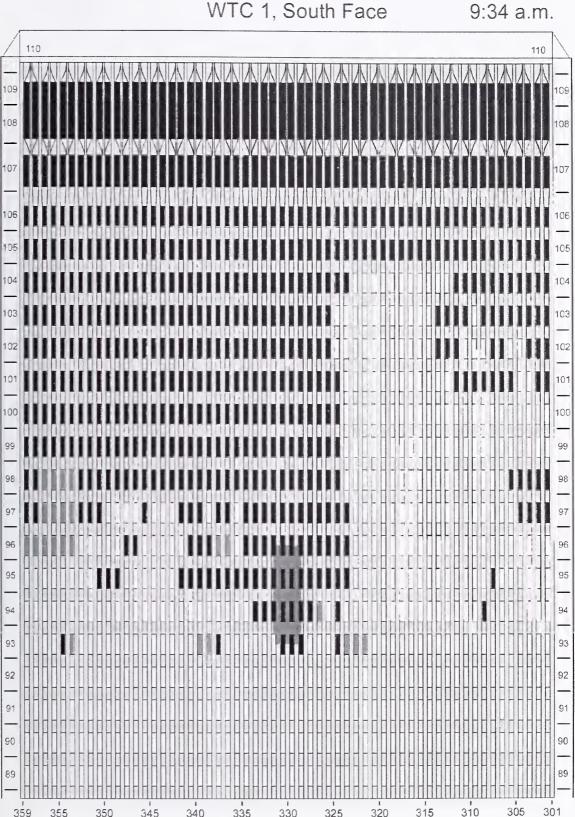
Figure E-24. Diagram of the south face of WTC 1 for floors 89 to 110 at 9:34 a.m. showing windows where smoke was observed and those that were hidden from view.

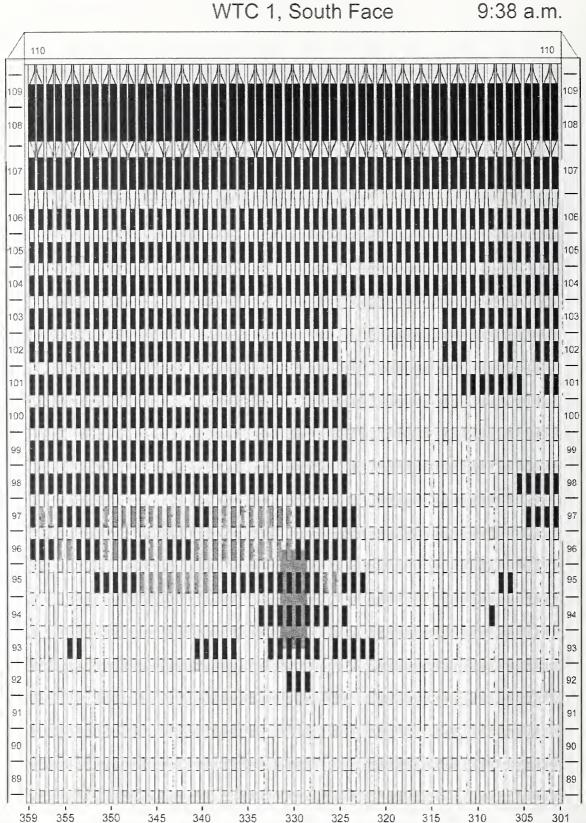
Figure E-25. Diagram of the south face of WTC 1 for floors 89 to 110 at 9:38 a.m. showing the condition of windows and locations of fires.

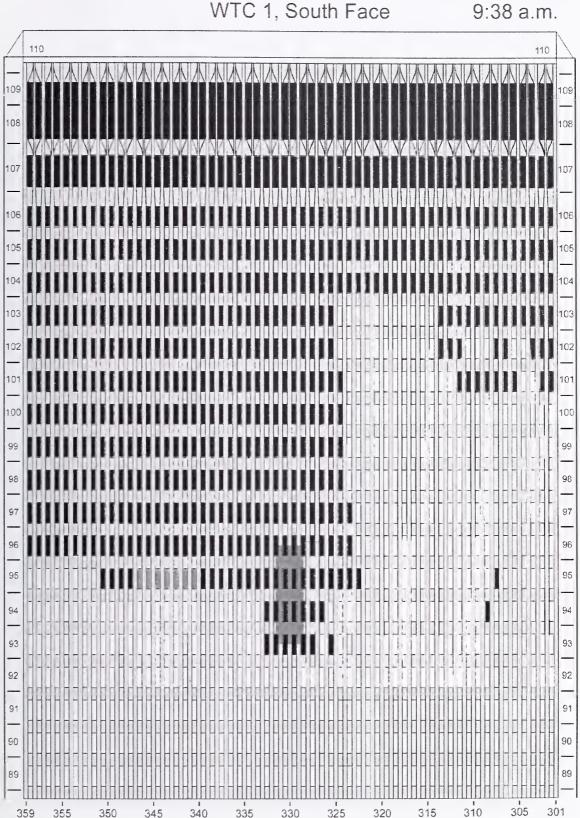
Figure E-26. Diagram of the south face of WTC 1 for floors 89 to 110 at 9:38 a.m. showing windows where smoke was observed and those that were hidden from view.

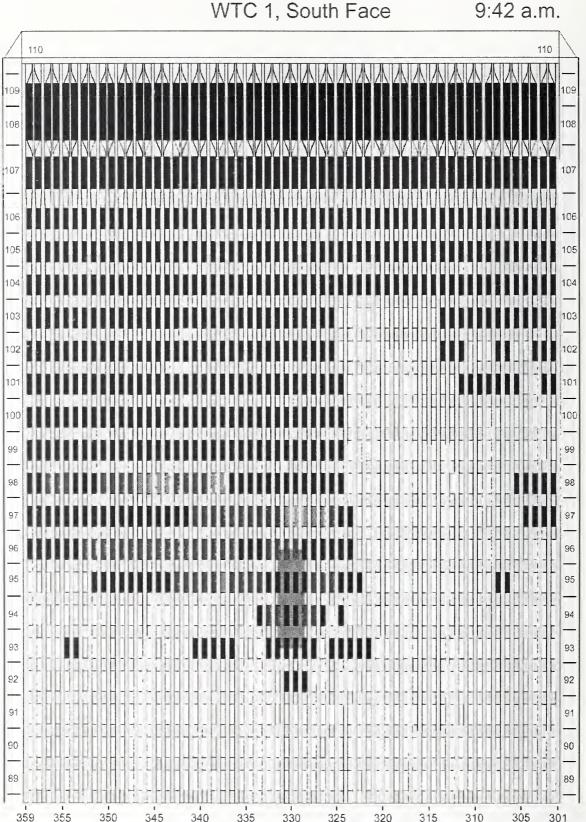
Figure E-27. Diagram of the south face of WTC 1 for floors 89 to 110 at 9:42 a.m. showing the condition of windows and locations of fires.

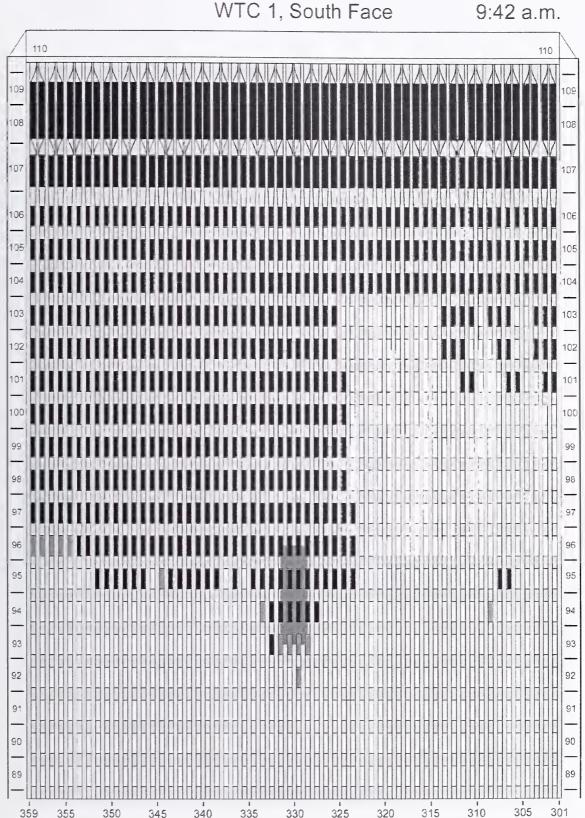
Figure E-28. Diagram of the south face of WTC 1 for floors 89 to 110 at 9:42 a.m. showing windows where smoke was observed and those that were hidden from view.

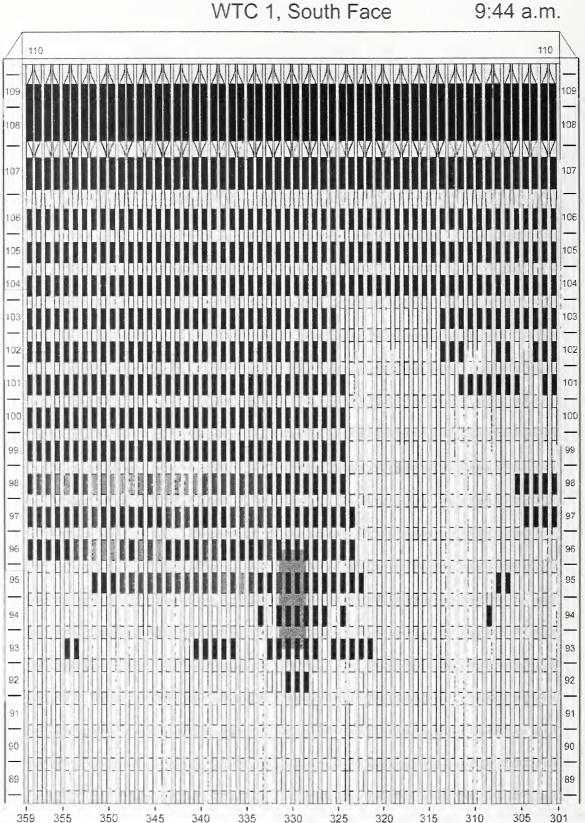
Figure E-29. Diagram of the south face of WTC 1 for floors 89 to 110 at 9:44 a.m. showing the condition of windows and locations of fires.

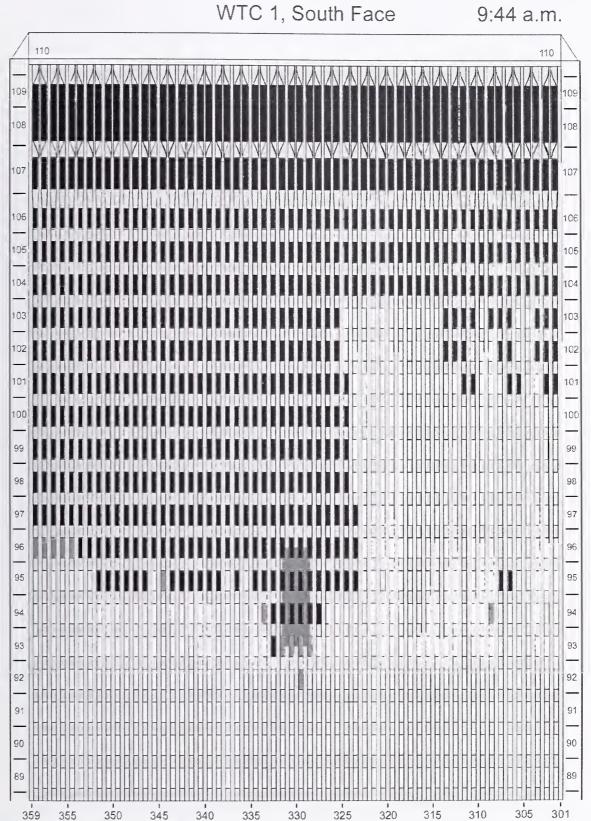
Figure E-30. Diagram of the south face of WTC 1 for floors 89 to 110 at 9:44 a.m. showing windows where smoke was observed and those that were hidden from view.

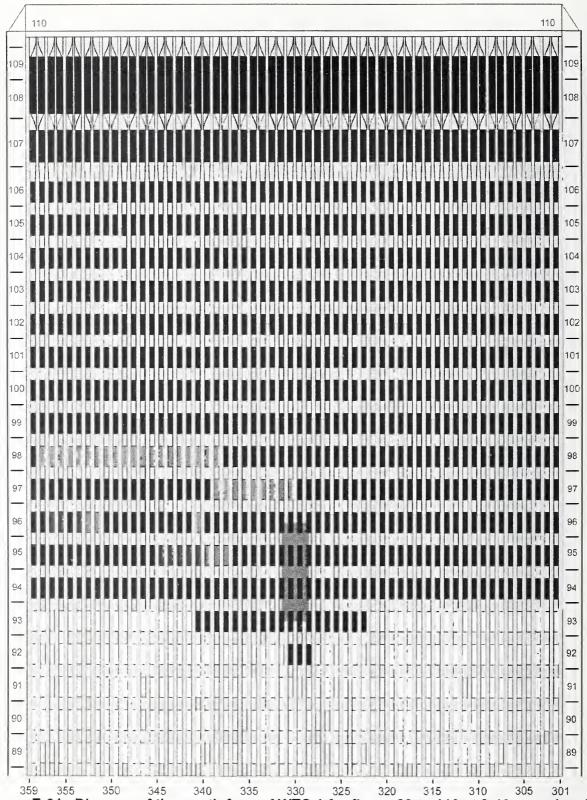
Figure E-31. Diagram of the south face of WTC 1 for floors 89 to 110 at 9:46 a.m. showing the condition of windows and locations of fires.

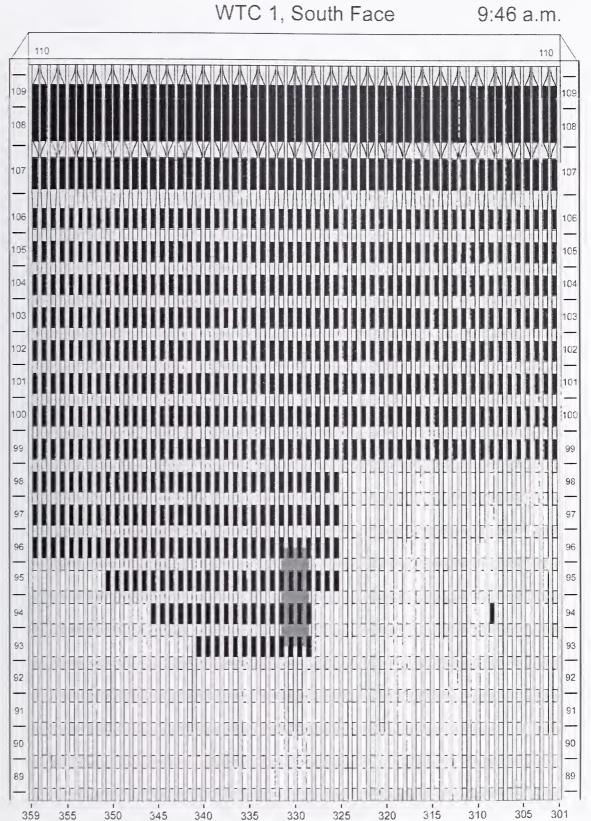
Figure E-32. Diagram of the south face of WTC 1 for floors 89 to 110 at 9:46 a.m. showing windows where smoke was observed and those that were hidden from view.

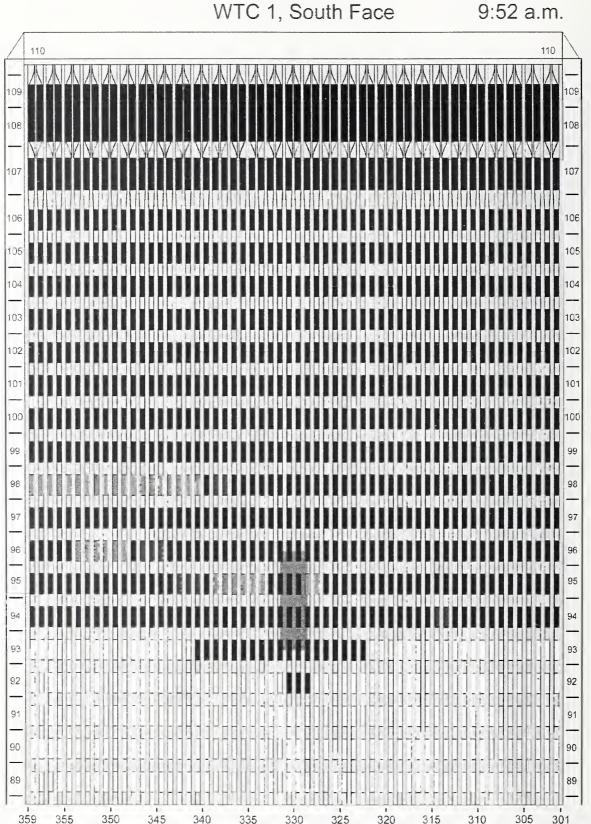
Figure E-33. Diagram of the south face of WTC 1 for floors 89 to 110 at 9:52 a.m. showing the condition of windows and locations of fires.

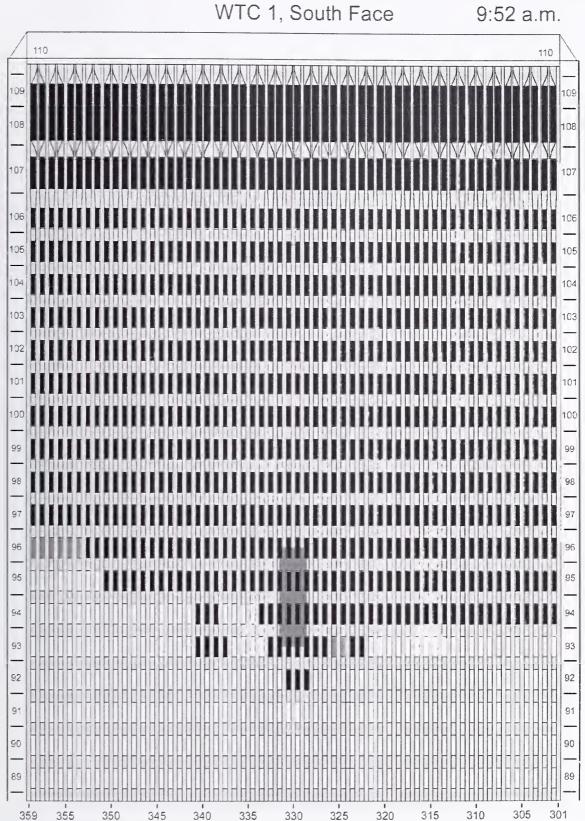
Figure E-34. Diagram of the south face of WTC 1 for floors 89 to 110 at 9:52 a.m. showing windows where smoke was observed and those that were hidden from view.

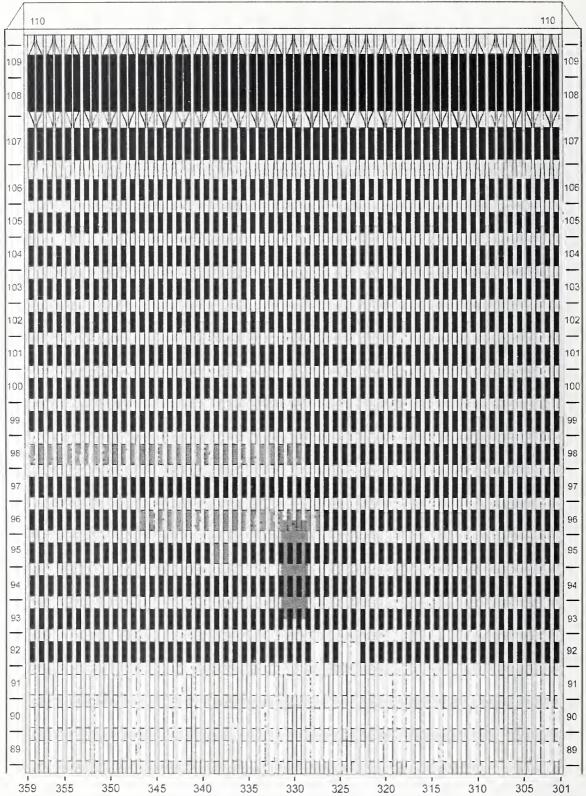
Figure E-35. Diagram of the south face of WTC 1 for floors 89 to 110 at 9:58 a.m. showing the condition of windows and locations of fires.

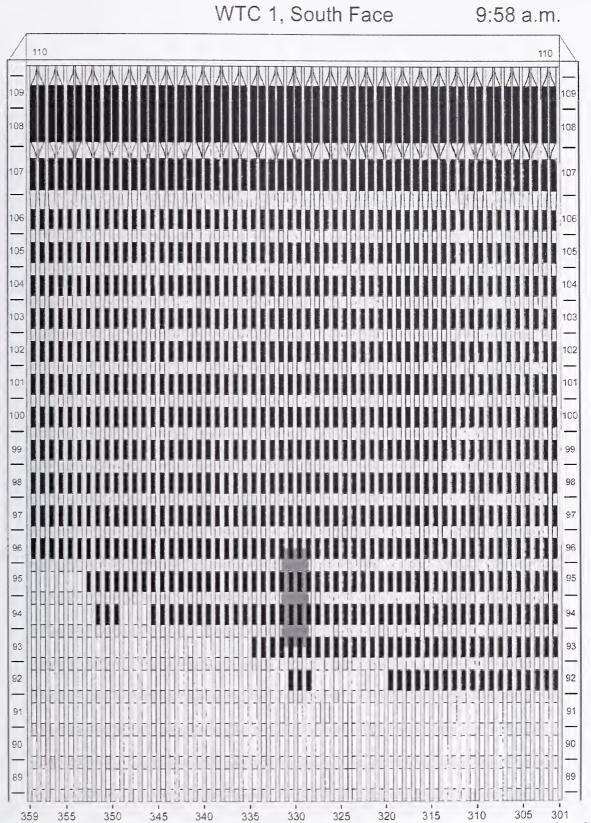
Figure E-36. Diagram of the south face of WTC 1 for floors 89 to 110 at 9:58 a.m. showing windows where smoke was observed and those that were hidden from view.

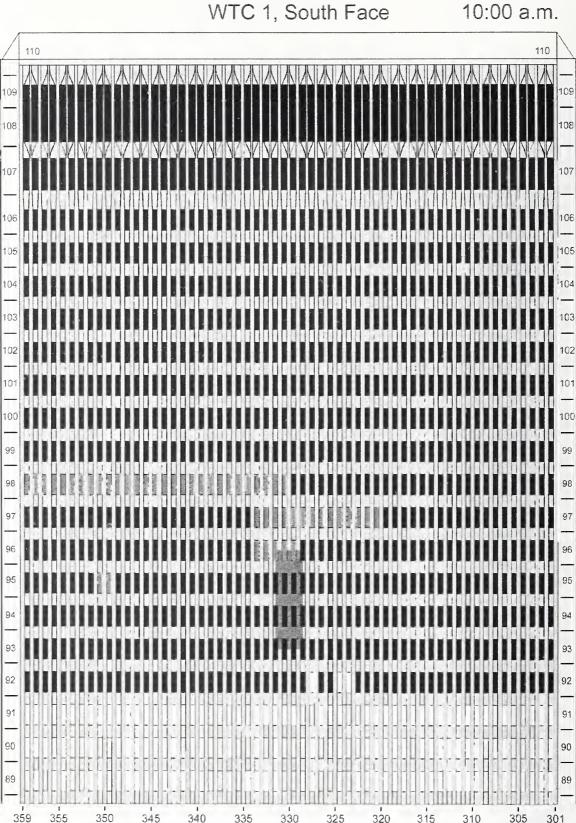
Figure E-37. Diagram of the south face of WTC 1 for floors 89 to 110 at 10:00 a.m. showing the condition of windows and locations of fires.

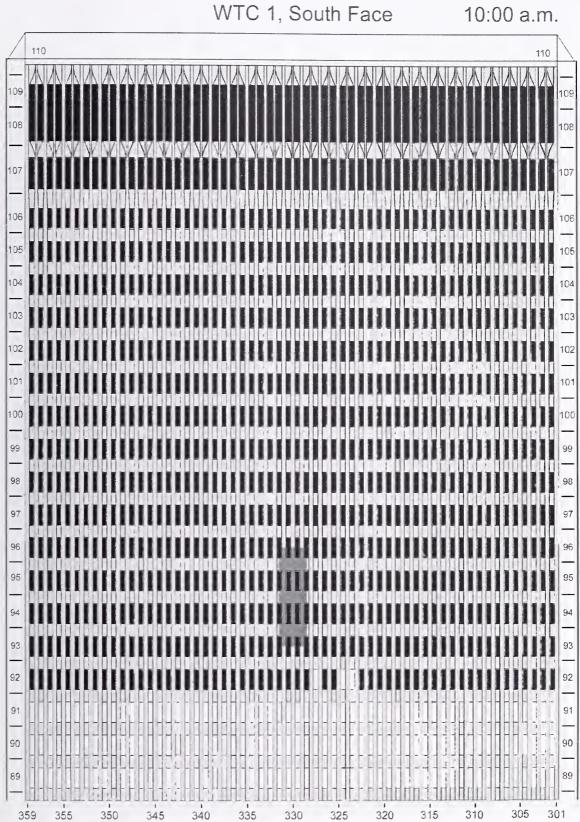
Figure E-38. Diagram of the south face of WTC 1 for floors 89 to 110 at 10:00 a.m. showing windows where smoke was observed and those that were hidden from view.

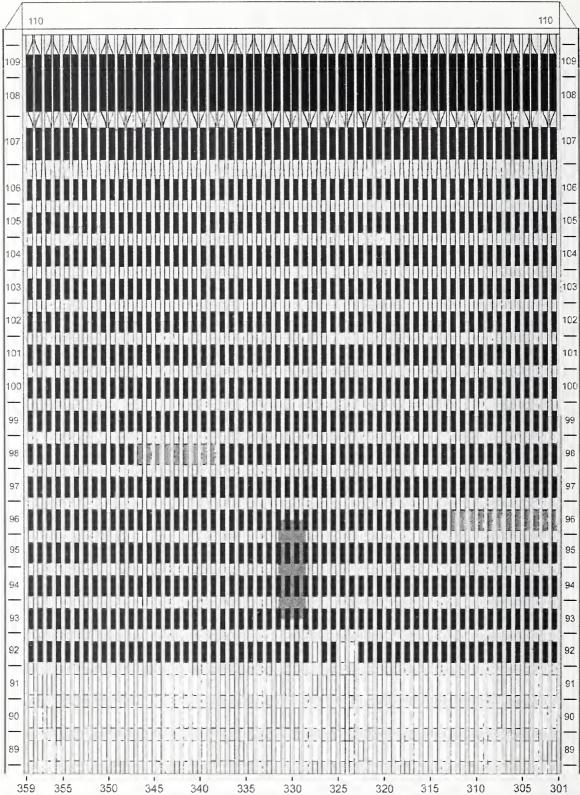
Figure E-39. Diagram of the south face of WTC 1 for floors 89 to 110 at 10:10 a.m. showing the condition of windows and locations of fires.

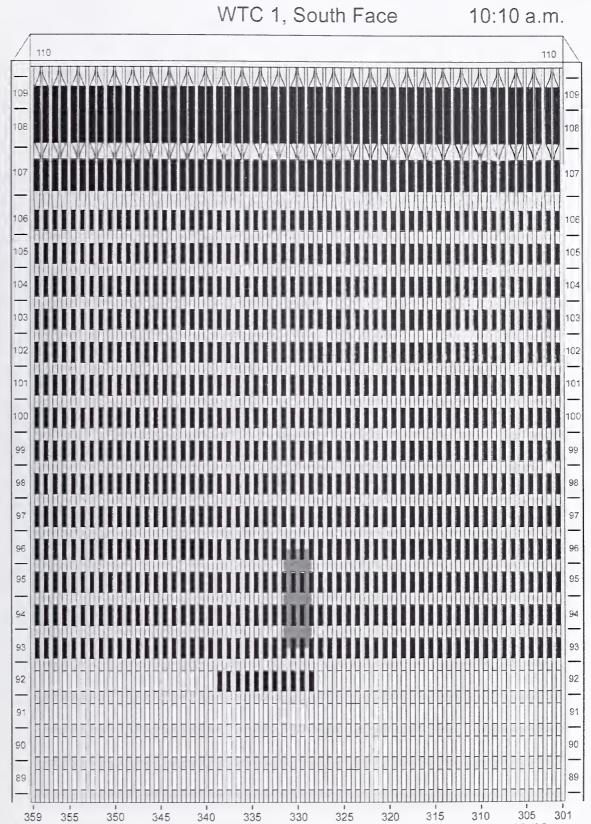
Figure E-40. Diagram of the south face of WTC 1 for floors 89 to 110 at 10:10 a.m. showing windows where smoke was observed and those that were hidden from view.

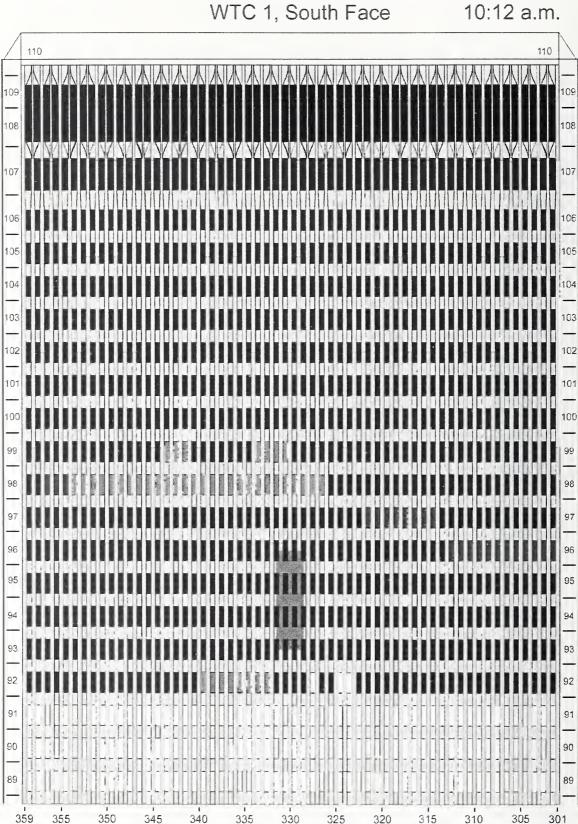
Figure E-41. Diagram of the south face of WTC 1 for floors 89 to 110 at 10:12 a.m. showing the condition of windows and locations of fires.

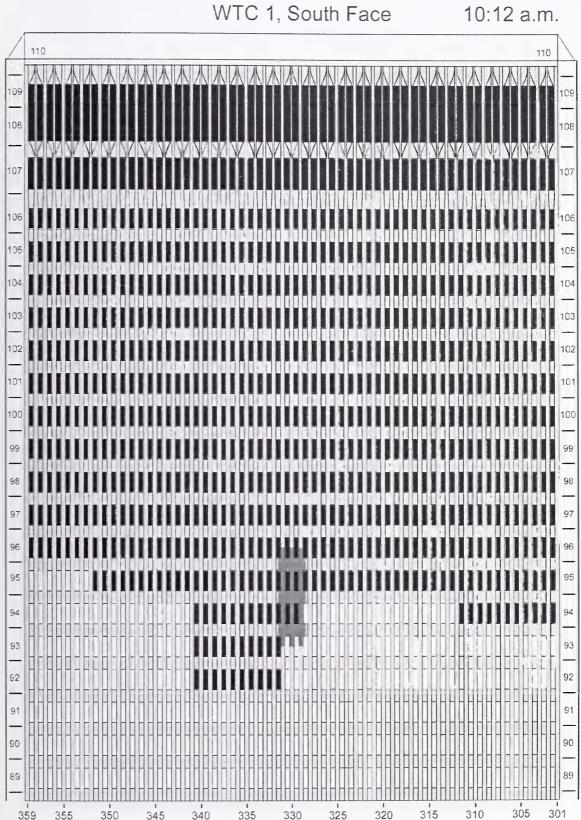
Figure E-42. Diagram of the south face of WTC 1 for floors 89 to 110 at 10:12 a.m. showing windows where smoke was observed and those that were hidden from view.

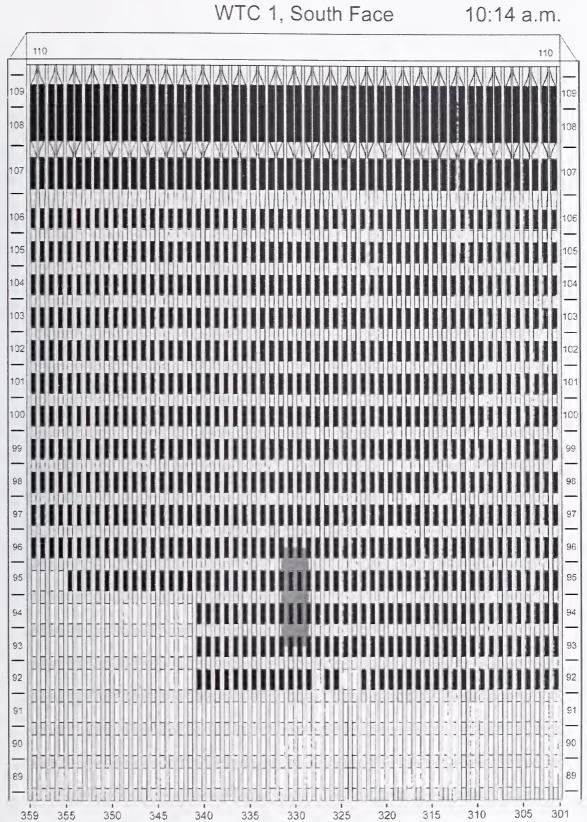
Figure E-44. Diagram of the south face of WTC 1 for floors 89 to 110 at 10:14 a.m. showing windows where smoke was observed and those that were hidden from view.

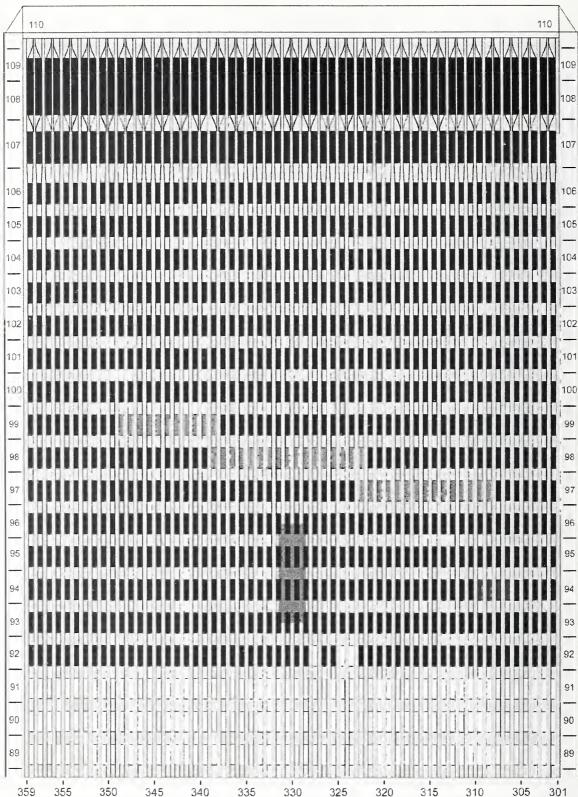
Figure E-45. Diagram of the south face of WTC 1 for floors 89 to 110 at 10:18 a.m. showing the condition of windows and locations of fires.
